Quarterly Progress Report

Grant #7310006

Arctic Thermal Shutters and Doors

Arctic Sun, LLC

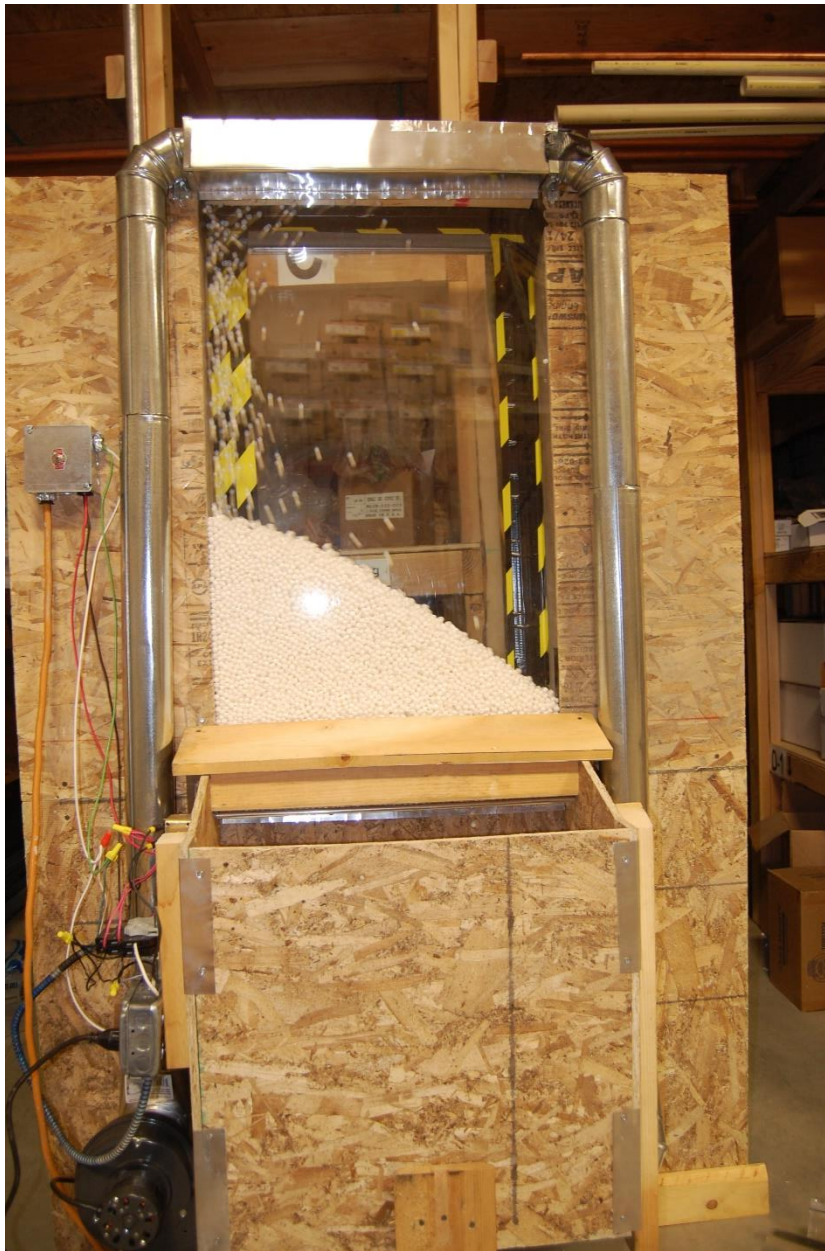
The photo below demonstrates the beads being blown into the cavity.

We tested the timed relays for their applicability in shutting the blower off, and were very pleased with the results. This should be an effective way to control the unit. During final testing of the prototype, we adjusted the ducting to be able to maintain a reliable, complete fill of the cavity. The final blown-in shutter design is attached for approval.

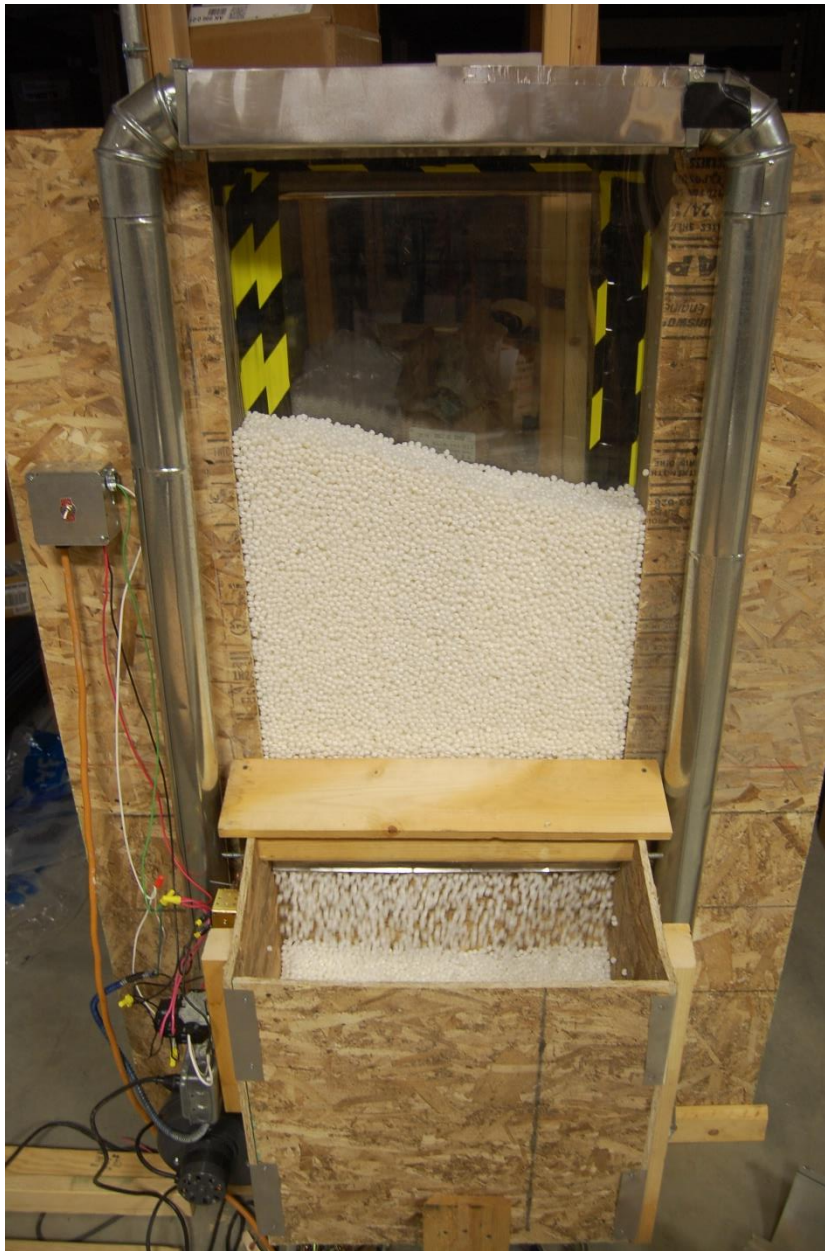
The photo below shows the drop-gate open and the beads falling into the storage area.
